STEAM BOILERS IN READY-MADE GARMENTS INDUSTRY IN BANGLADESH: EXISTING SCENARIO AND SCOPE FOR DEVELOPMENT

¹Boiler Safety Engineering Department, RMG Sustainability Council, Dhaka, Bangladesh

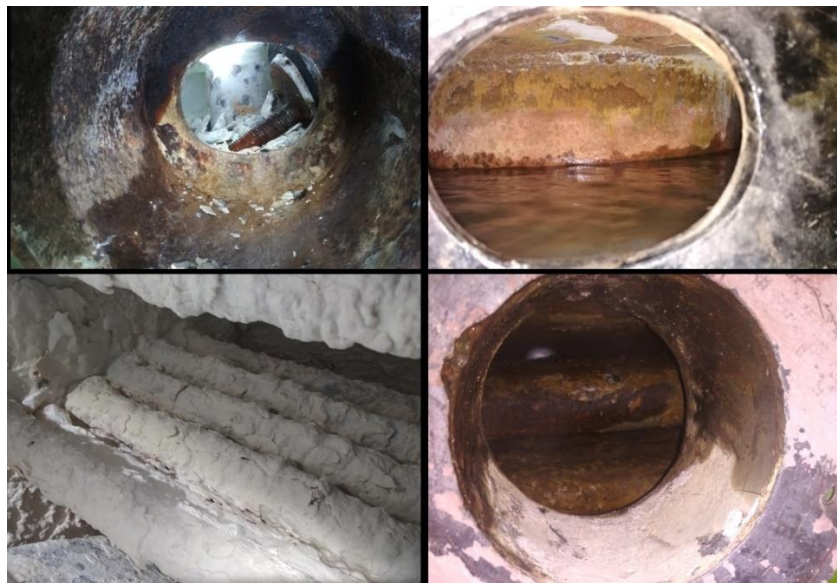
Figure 1: Corrosion of the metal and scale formation inside the boiler for using untreated water (Accord, 2019; Siraj *et al.*, 2023)

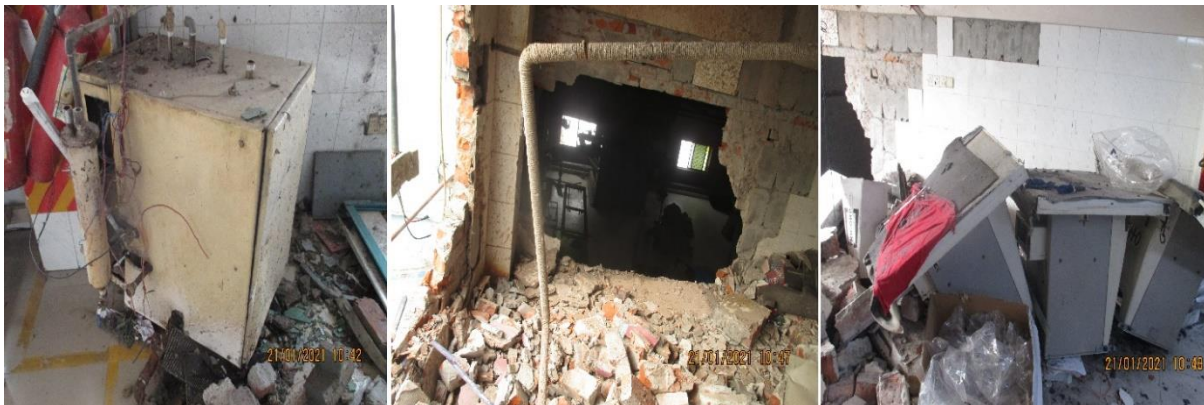
The inspectors of the RSC found a non-compliance operational issue behind that explosion. They reported, the factory modified the level sensor of the boiler by increasing its length, which caused a dry-run of the boiler.

Figure 3: Mini-boiler (left), collapsed boiler room (middle), impact on the adjacent production floor (right); observed during the Incident inspection by the RSC at Sincere Composite Ltd.

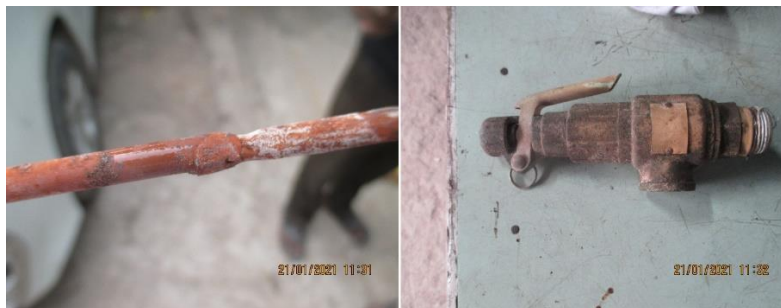
Moreover, the mechanical safety valve got stuck due to irregular maintenance and rust formation. Figure 4 is showing the investigated causes of the mini-boiler explosion at Sincere Composite Ltd.

Figure 4: Lengthening the level sensor by welding (left), rusted stuck safety valve (right); observed during the Incident inspection by the RSC at Sincere Composite Ltd.

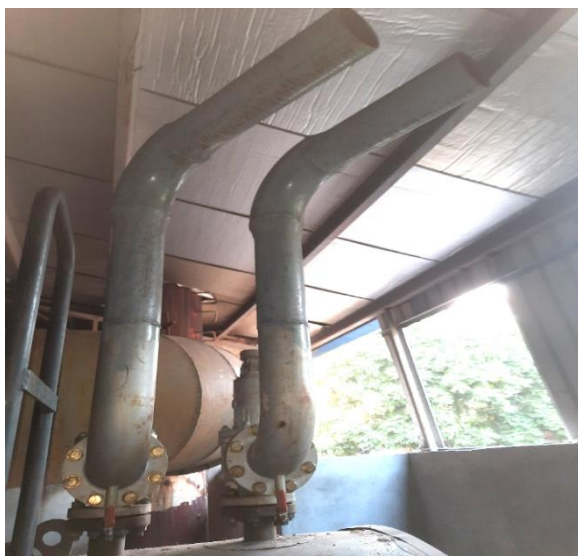
Figure 8: Safety valve discharge point inside the room

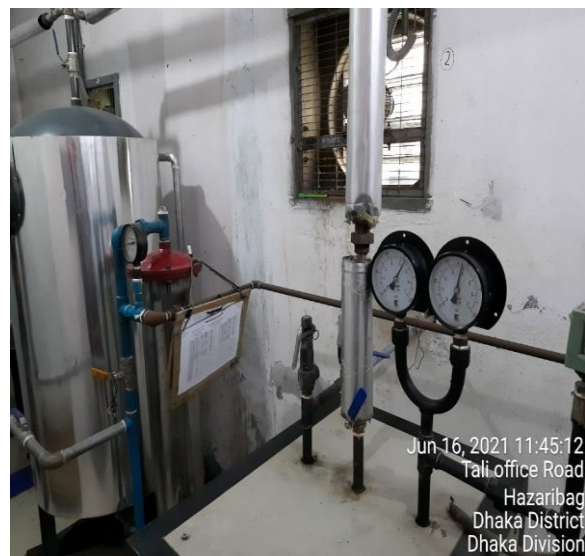
Figure 9: Different steam pressure at two gauges

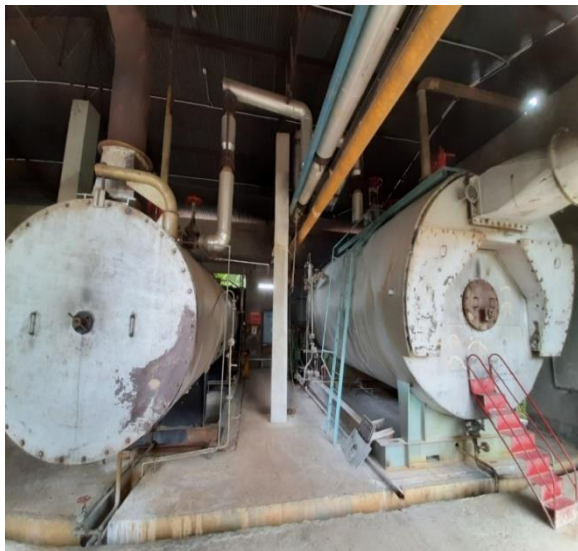
Figure 10: No railing for the service platform of boilers

Risk categories	Risk factors	Remediation suggestions
Platform	The boiler handrail, platform, and ladder are not provided/ are inadequately supported.	A Suitable and properly supported boiler handrail and platform shall be provided with proper ladder access.

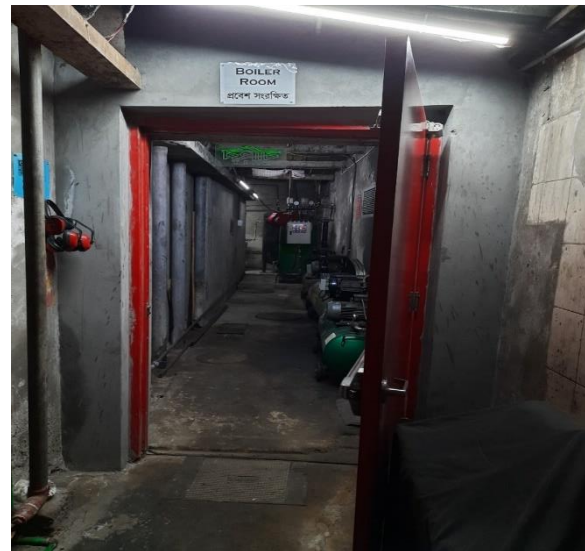
Figure 11: Inadequate clearance, obstructed ventilation

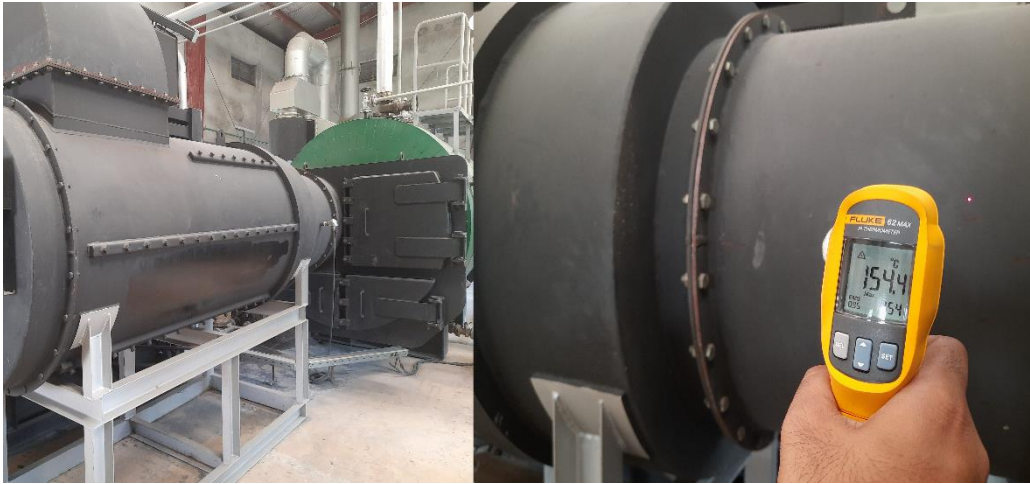
Figure 12: Uninsulated hot surface in the boiler room
