STEAM BOILERS IN READY-MADE GARMENTS INDUSTRY IN BANGLADESH: EXISTING SCENARIO AND SCOPE FOR DEVELOPMENT

¹Boiler Safety Engineering Department, RMG Sustainability Council, Dhaka, Bangladesh

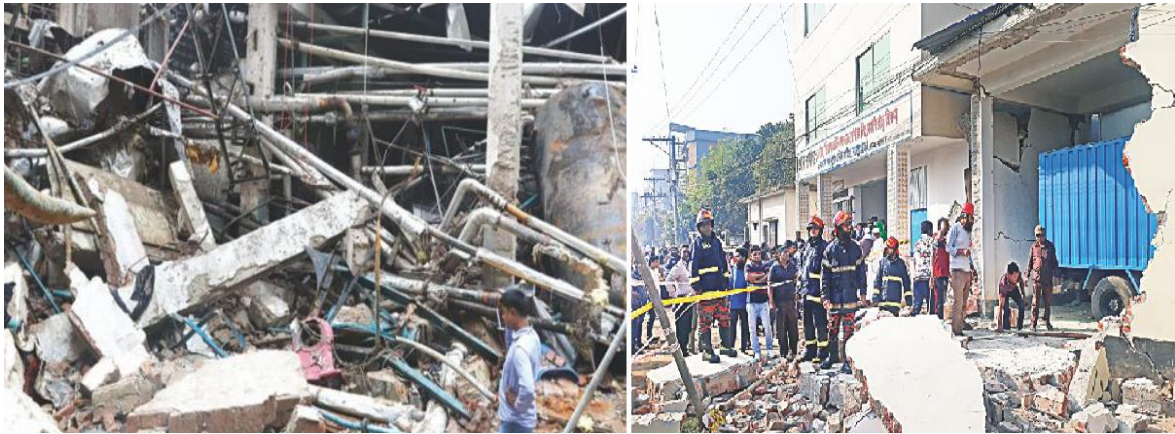
Figure 2: Boiler explosion at Multifabs Ltd on July 3, 2017 (Left) (“Boiler explosion”, 2017), and at Natural Sweater Village Ltd on December 10, 2019 (Right) (“One killed”, 2019)
